# **FLOOD PLAIN MANAGEMENT**

**A Study Of South Fork  
Shenandoah Tributaries**

**Rockingham County, Virginia**

**CUB RUN – BIG RUN**

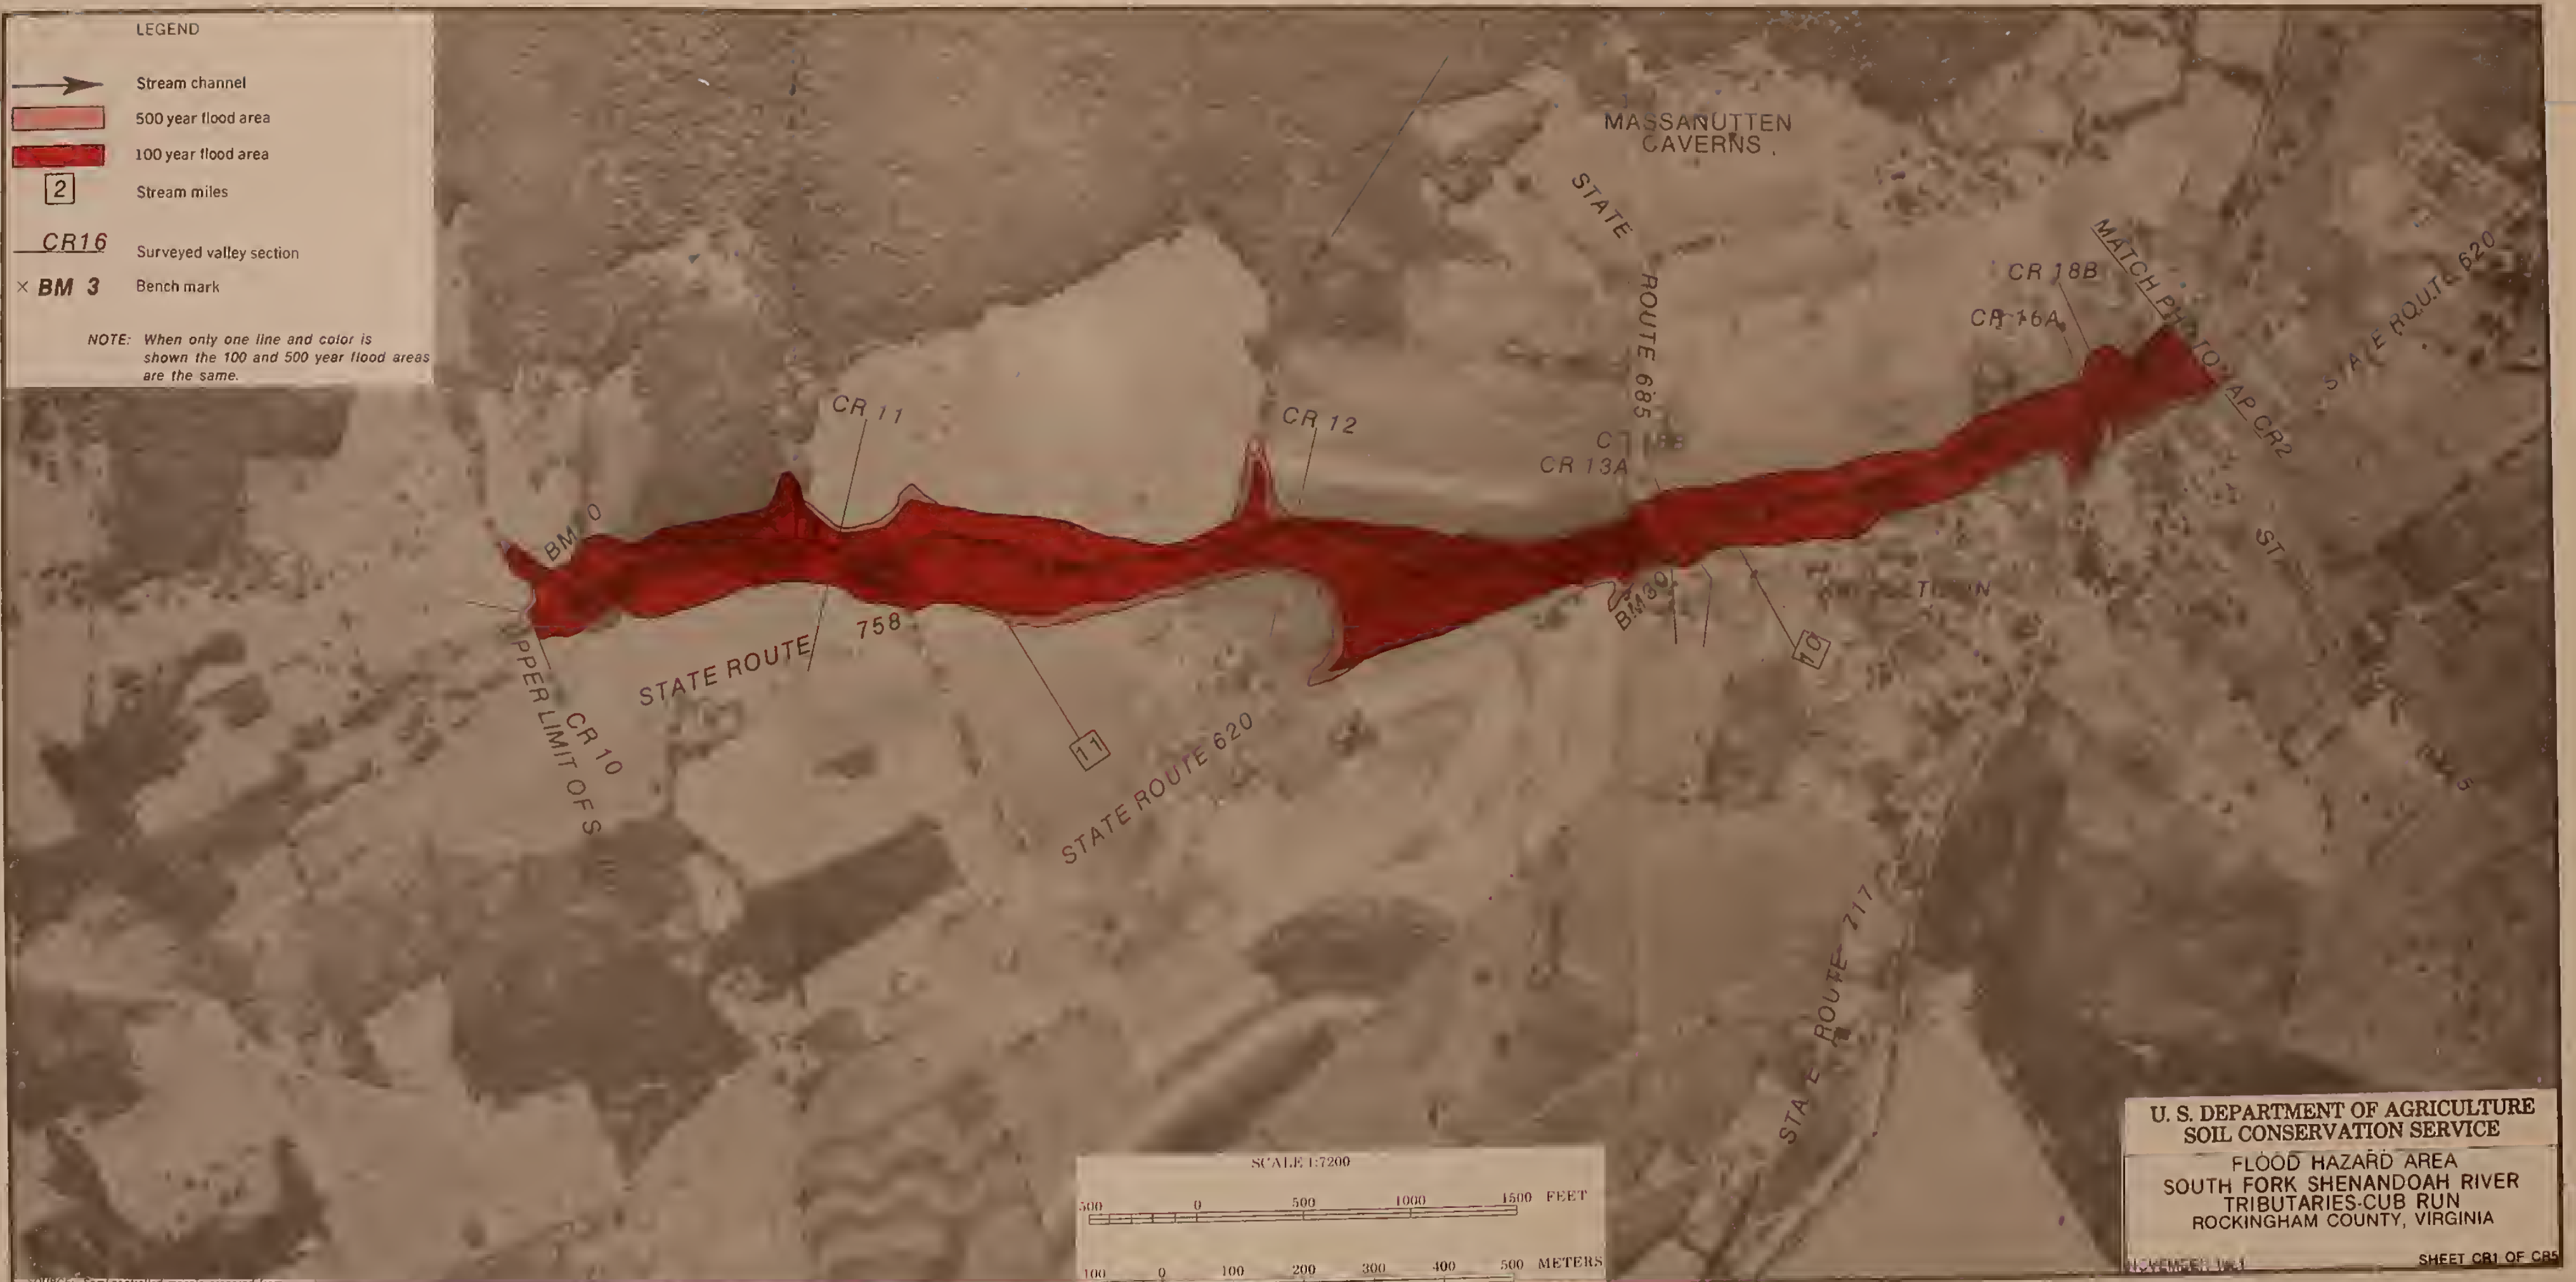
SHEET CR1 OF CR5

FLOOD HAZARD AREA  
SOUTH FORK SHENANDOAH RIVER  
TRIBUTARIES-CUB RUN  
ROCKINGHAM COUNTY, VIRGINIA

The index map shows the area covered by the individual photomaps. Flood hazard photomaps show the area inundated by the 100 and 500-year floods. Where only one line is shown, there is no significant difference in the boundaries of the two flood areas. These photomaps should only be used to determine approximate flood elevations; they are based on semicontrolled mosaics and the boundaries shown may vary from the location on the ground.

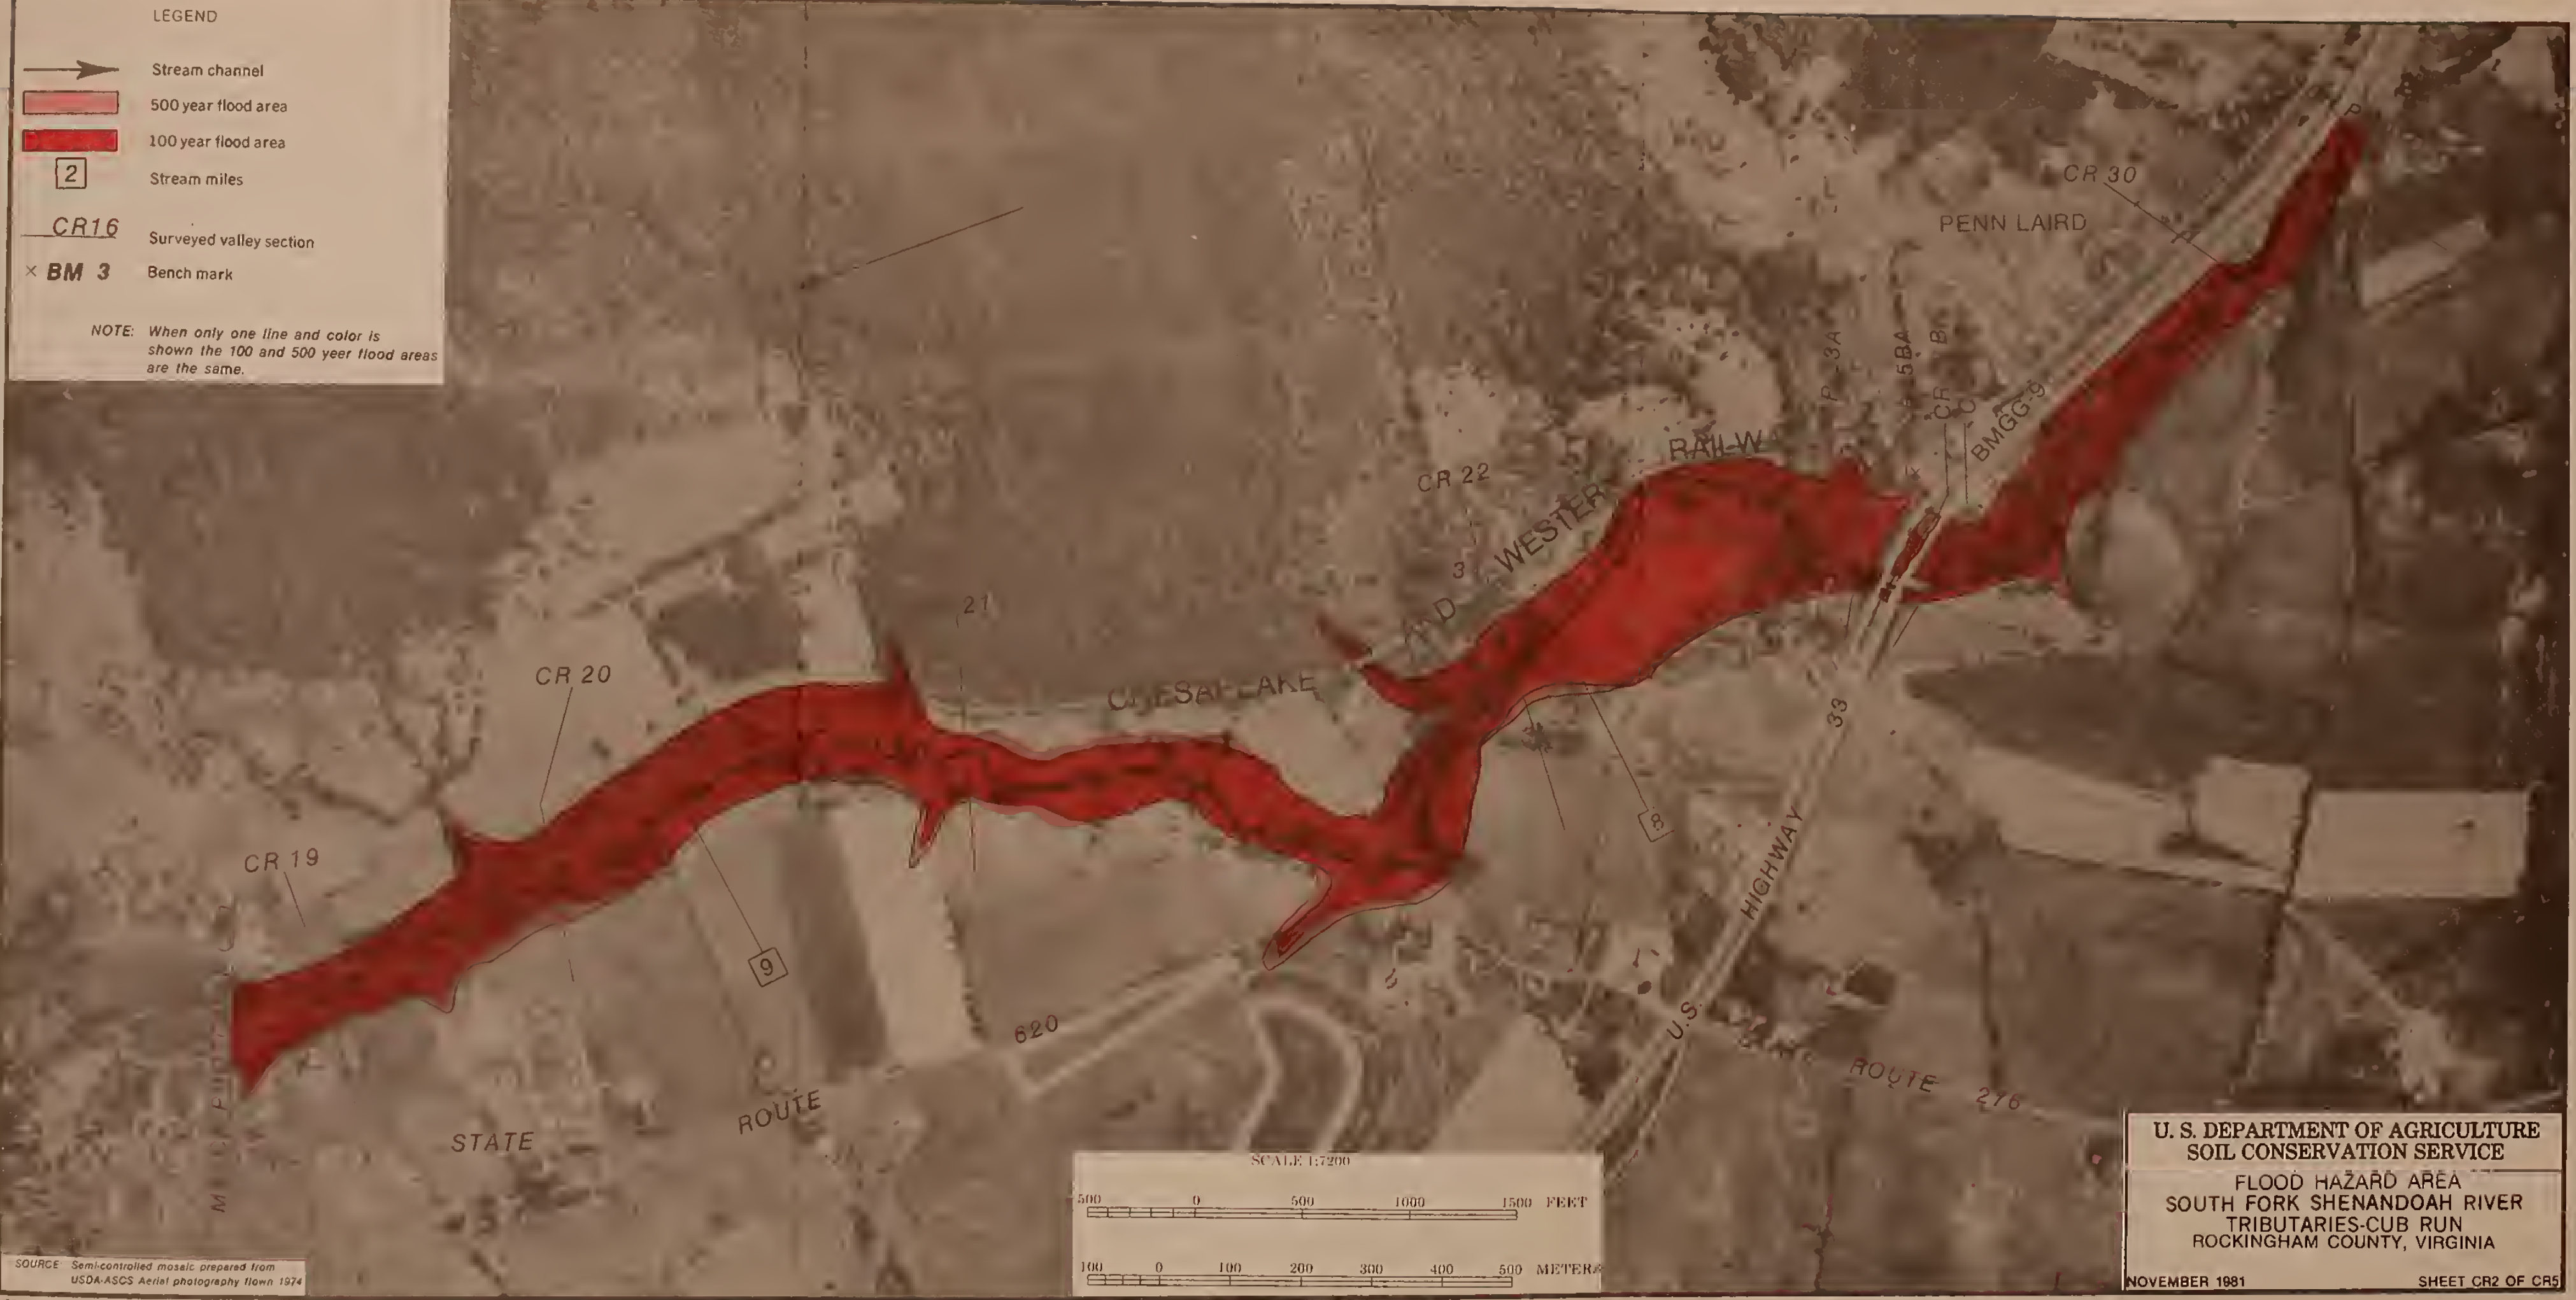
SHEET CR2 OF CR5

FLOOD HAZARD AREA  
SOUTH FORK SHENANDOAH RIVER  
TRIBUTARIES-CUB RUN  
ROCKINGHAM COUNTY, VIRGINIA

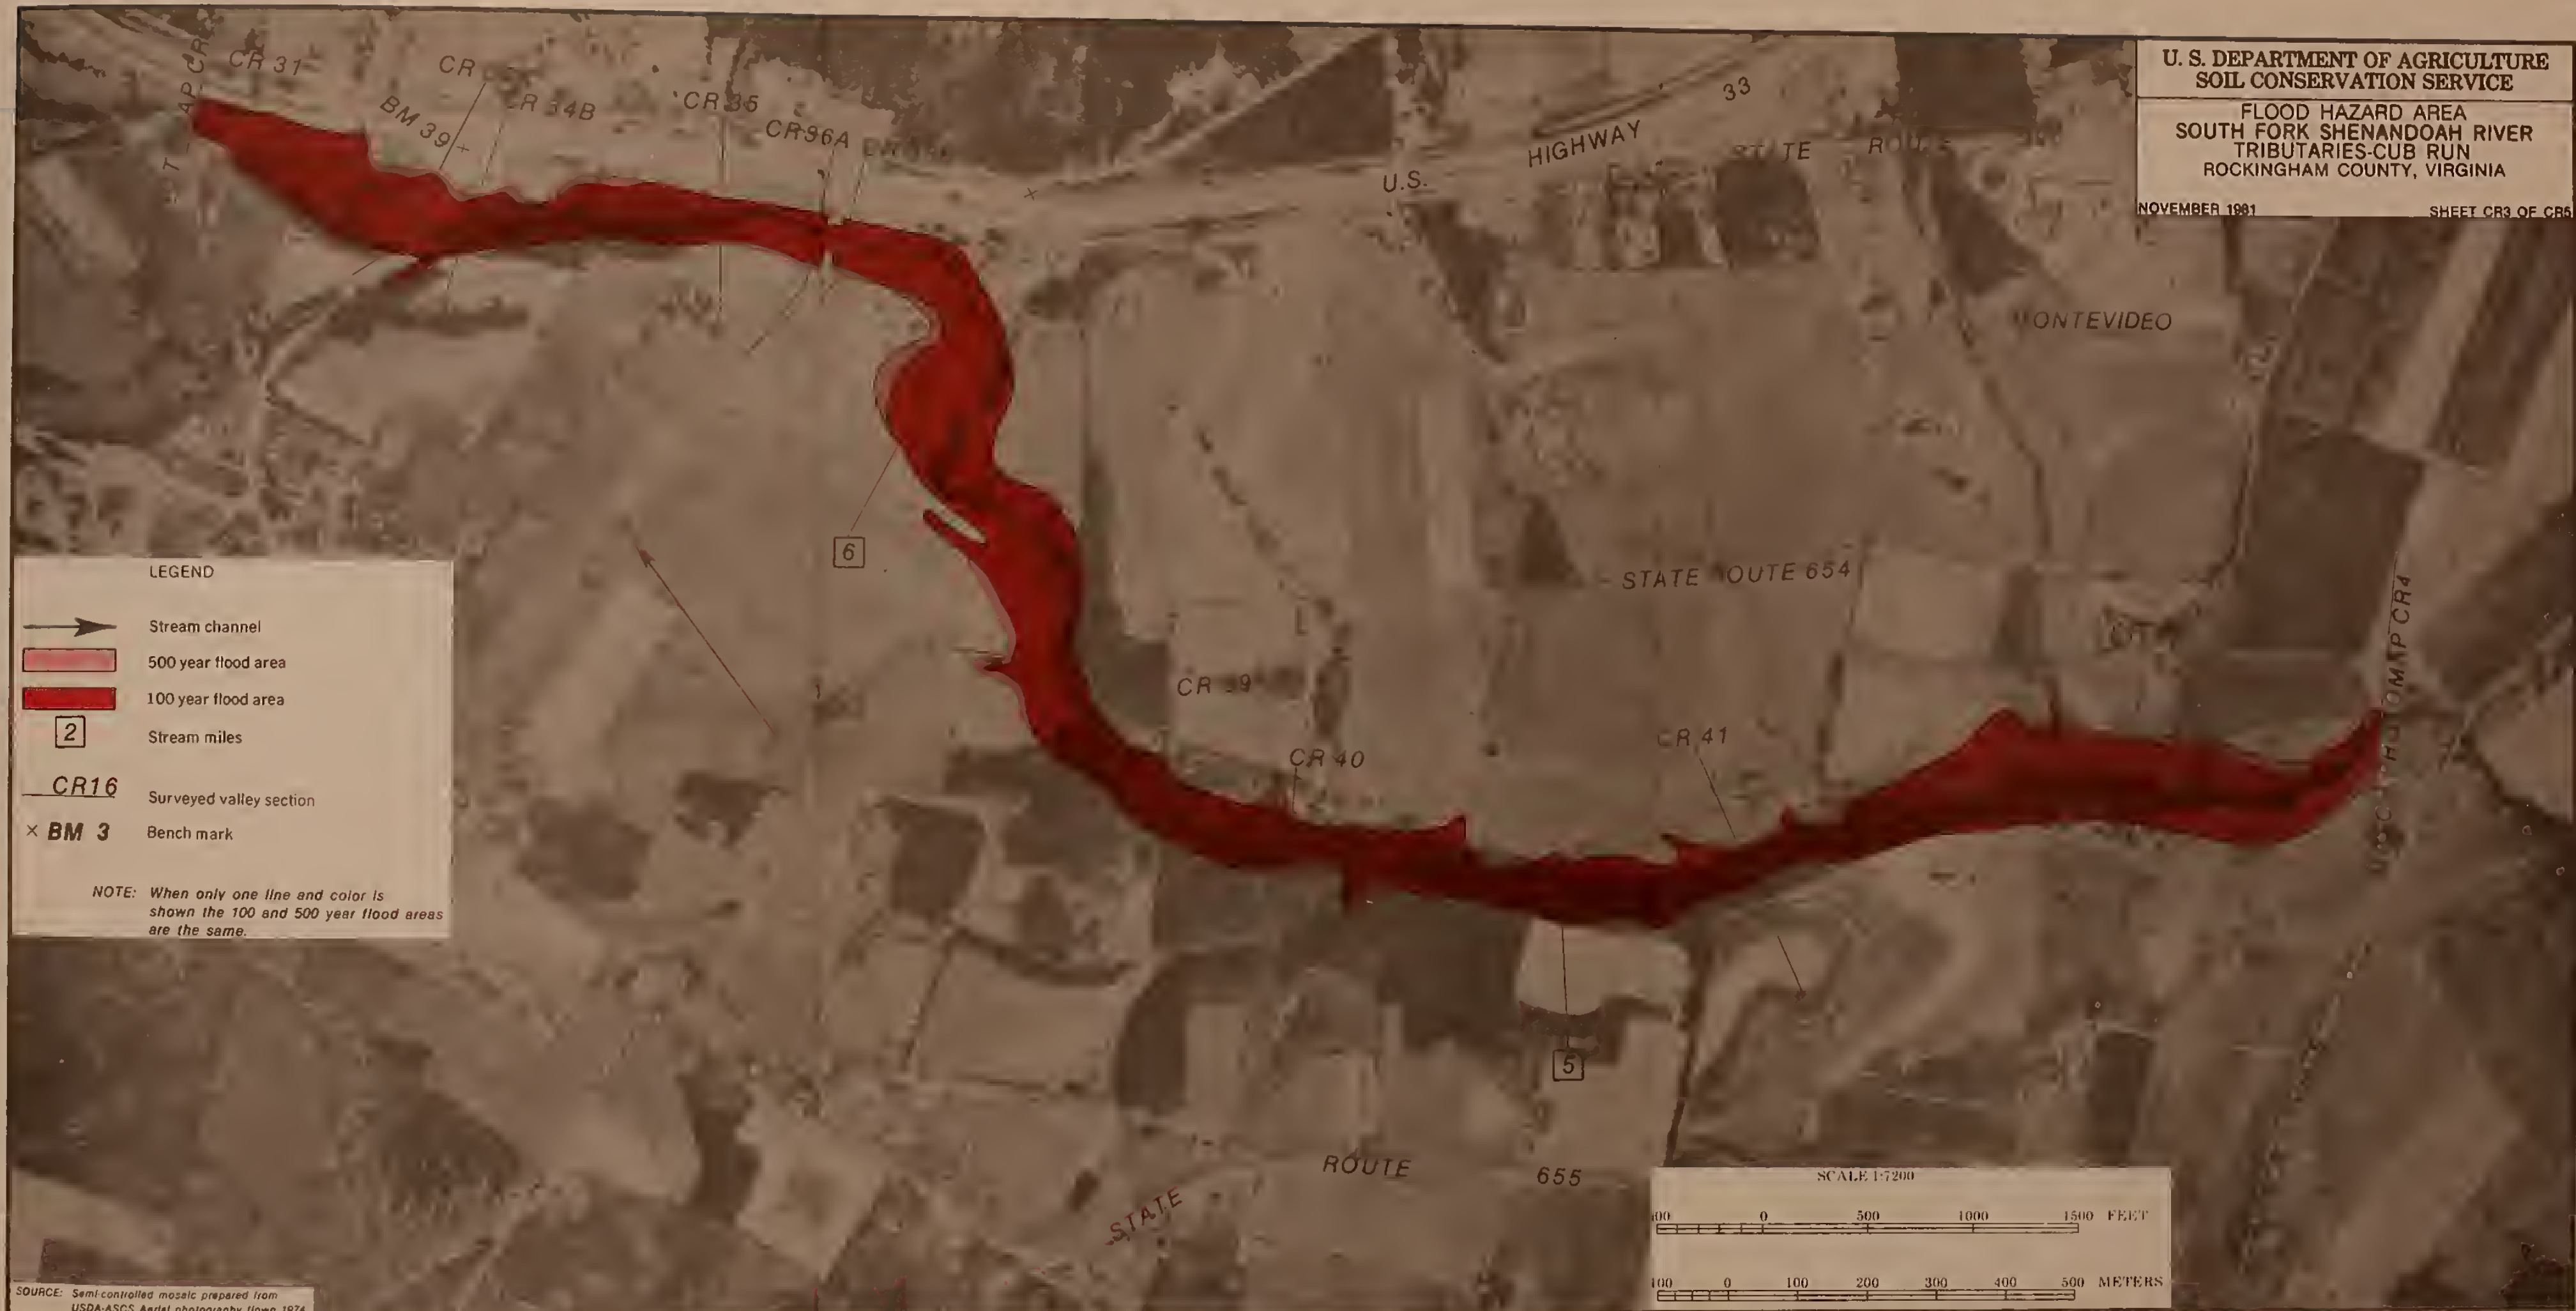
SHEET CR3 OF CR5

FLOOD HAZARD AREA  
SOUTH FORK SHENANDOAH RIVER  
TRIBUTARIES-CUB RUN  
ROCKINGHAM COUNTY, VIRGINIA

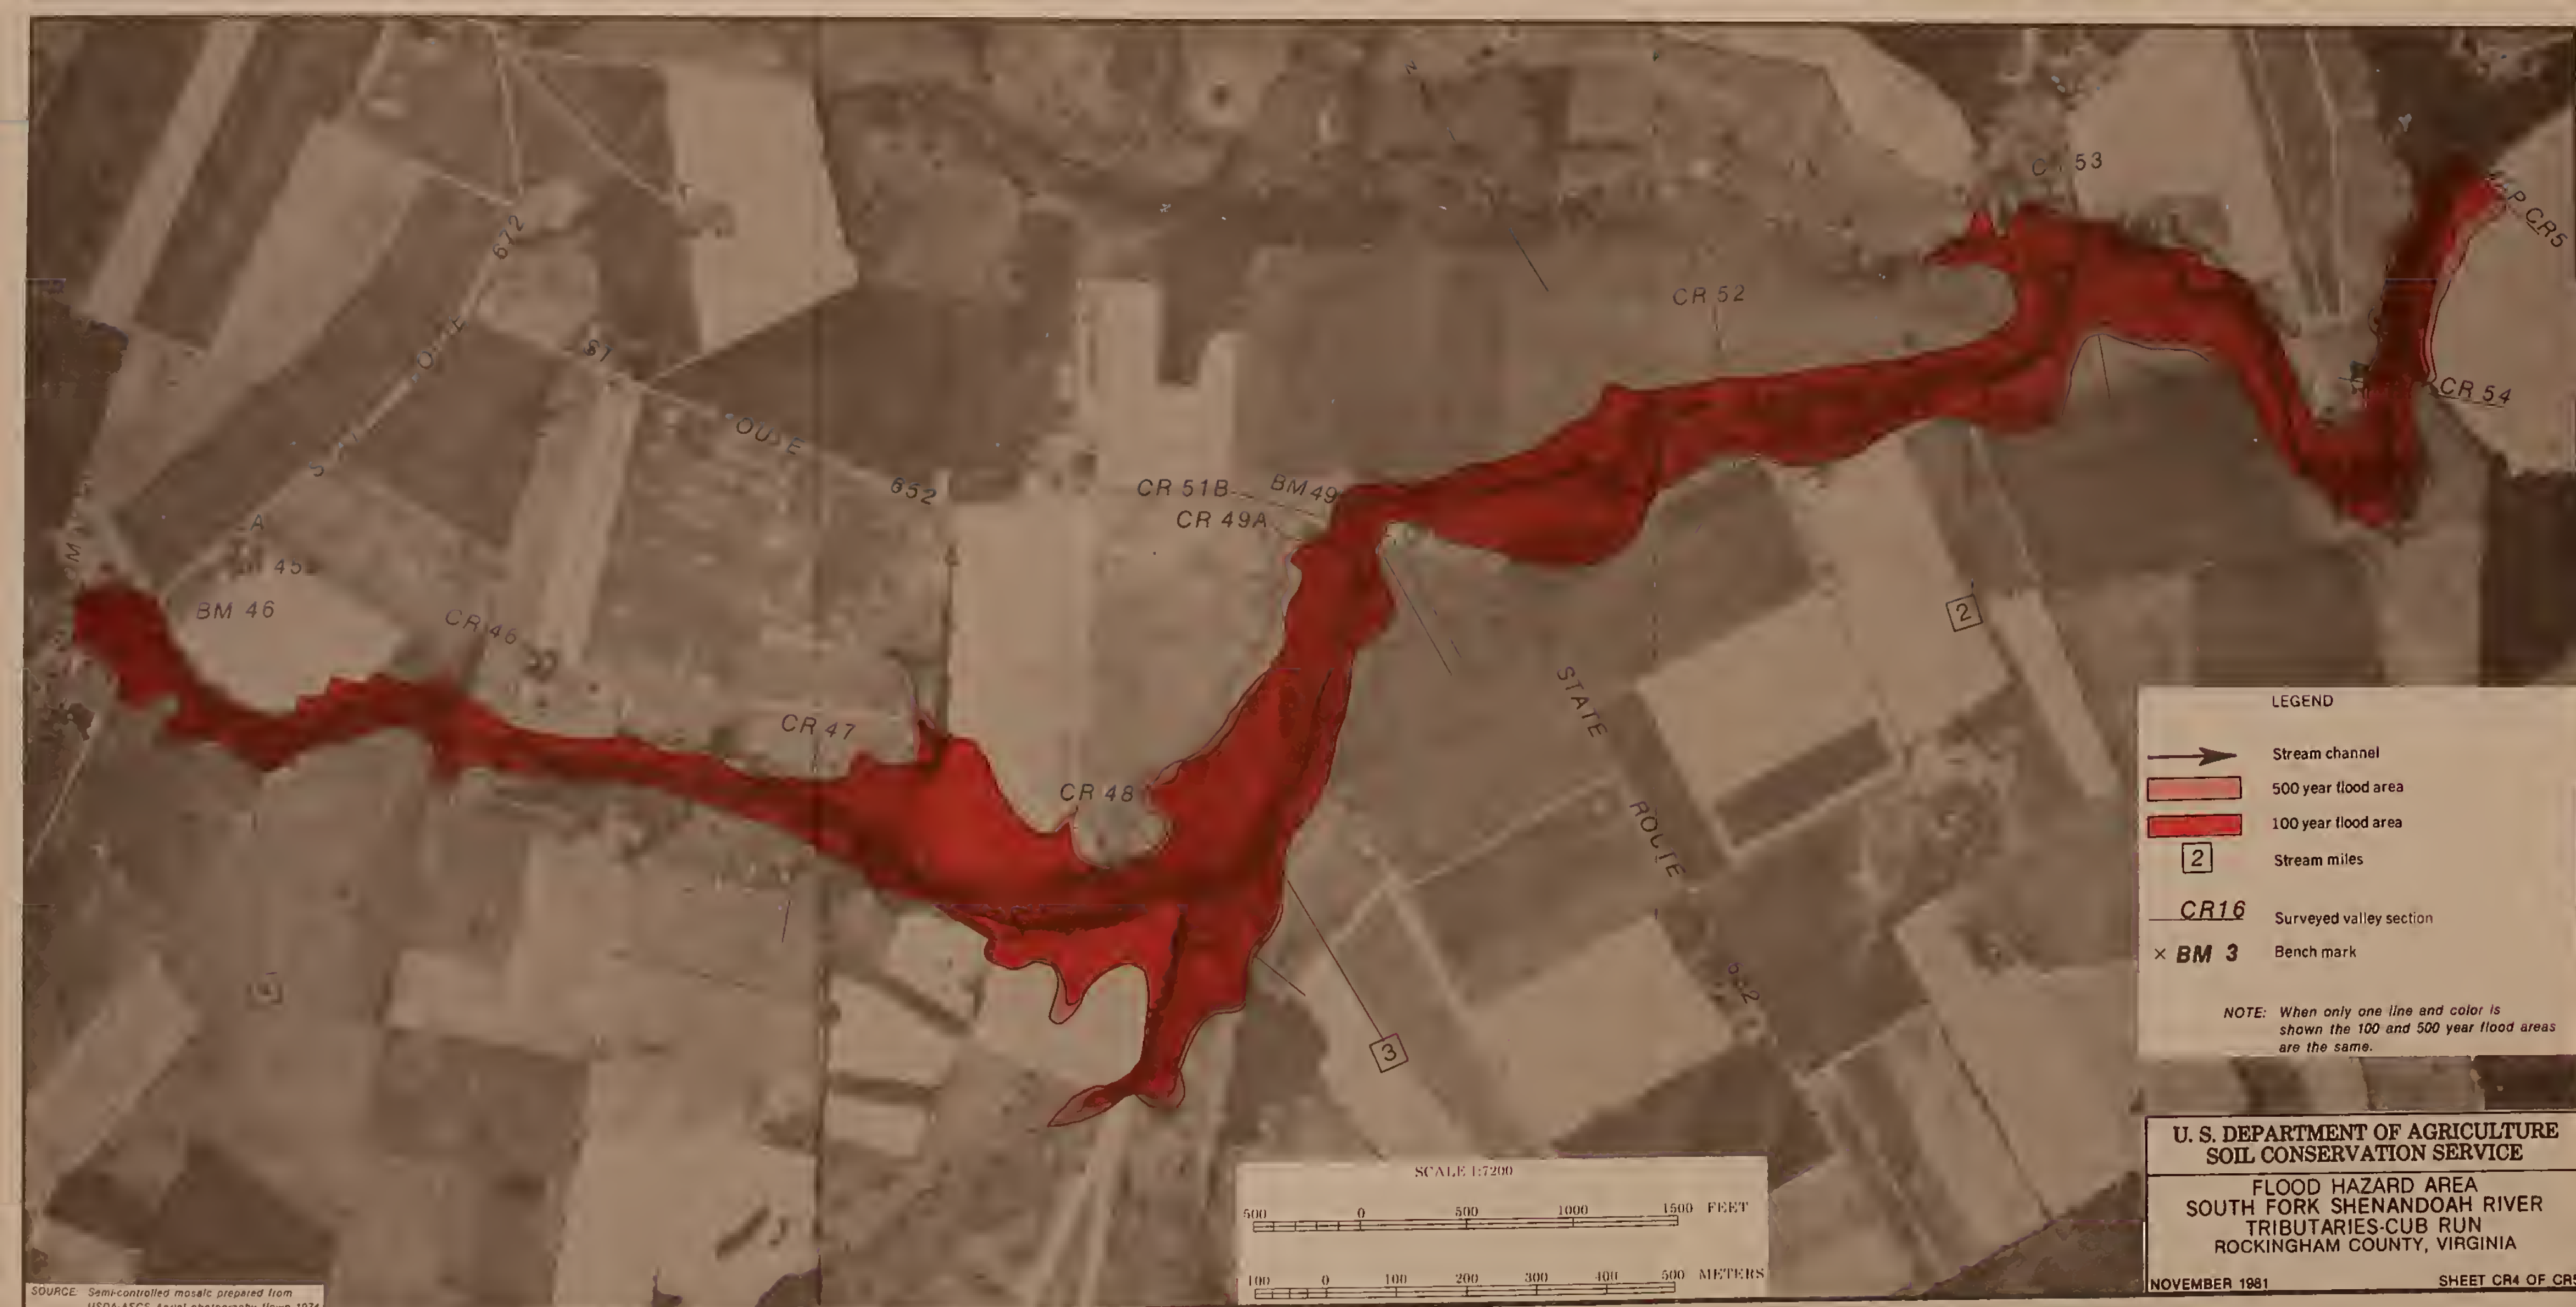
SHEET CR4 OF CR5

FLOOD HAZARD AREA  
SOUTH FORK SHENANDOAH RIVER  
TRIBUTARIES-CUB RUN  
ROCKINGHAM COUNTY, VIRGINIA

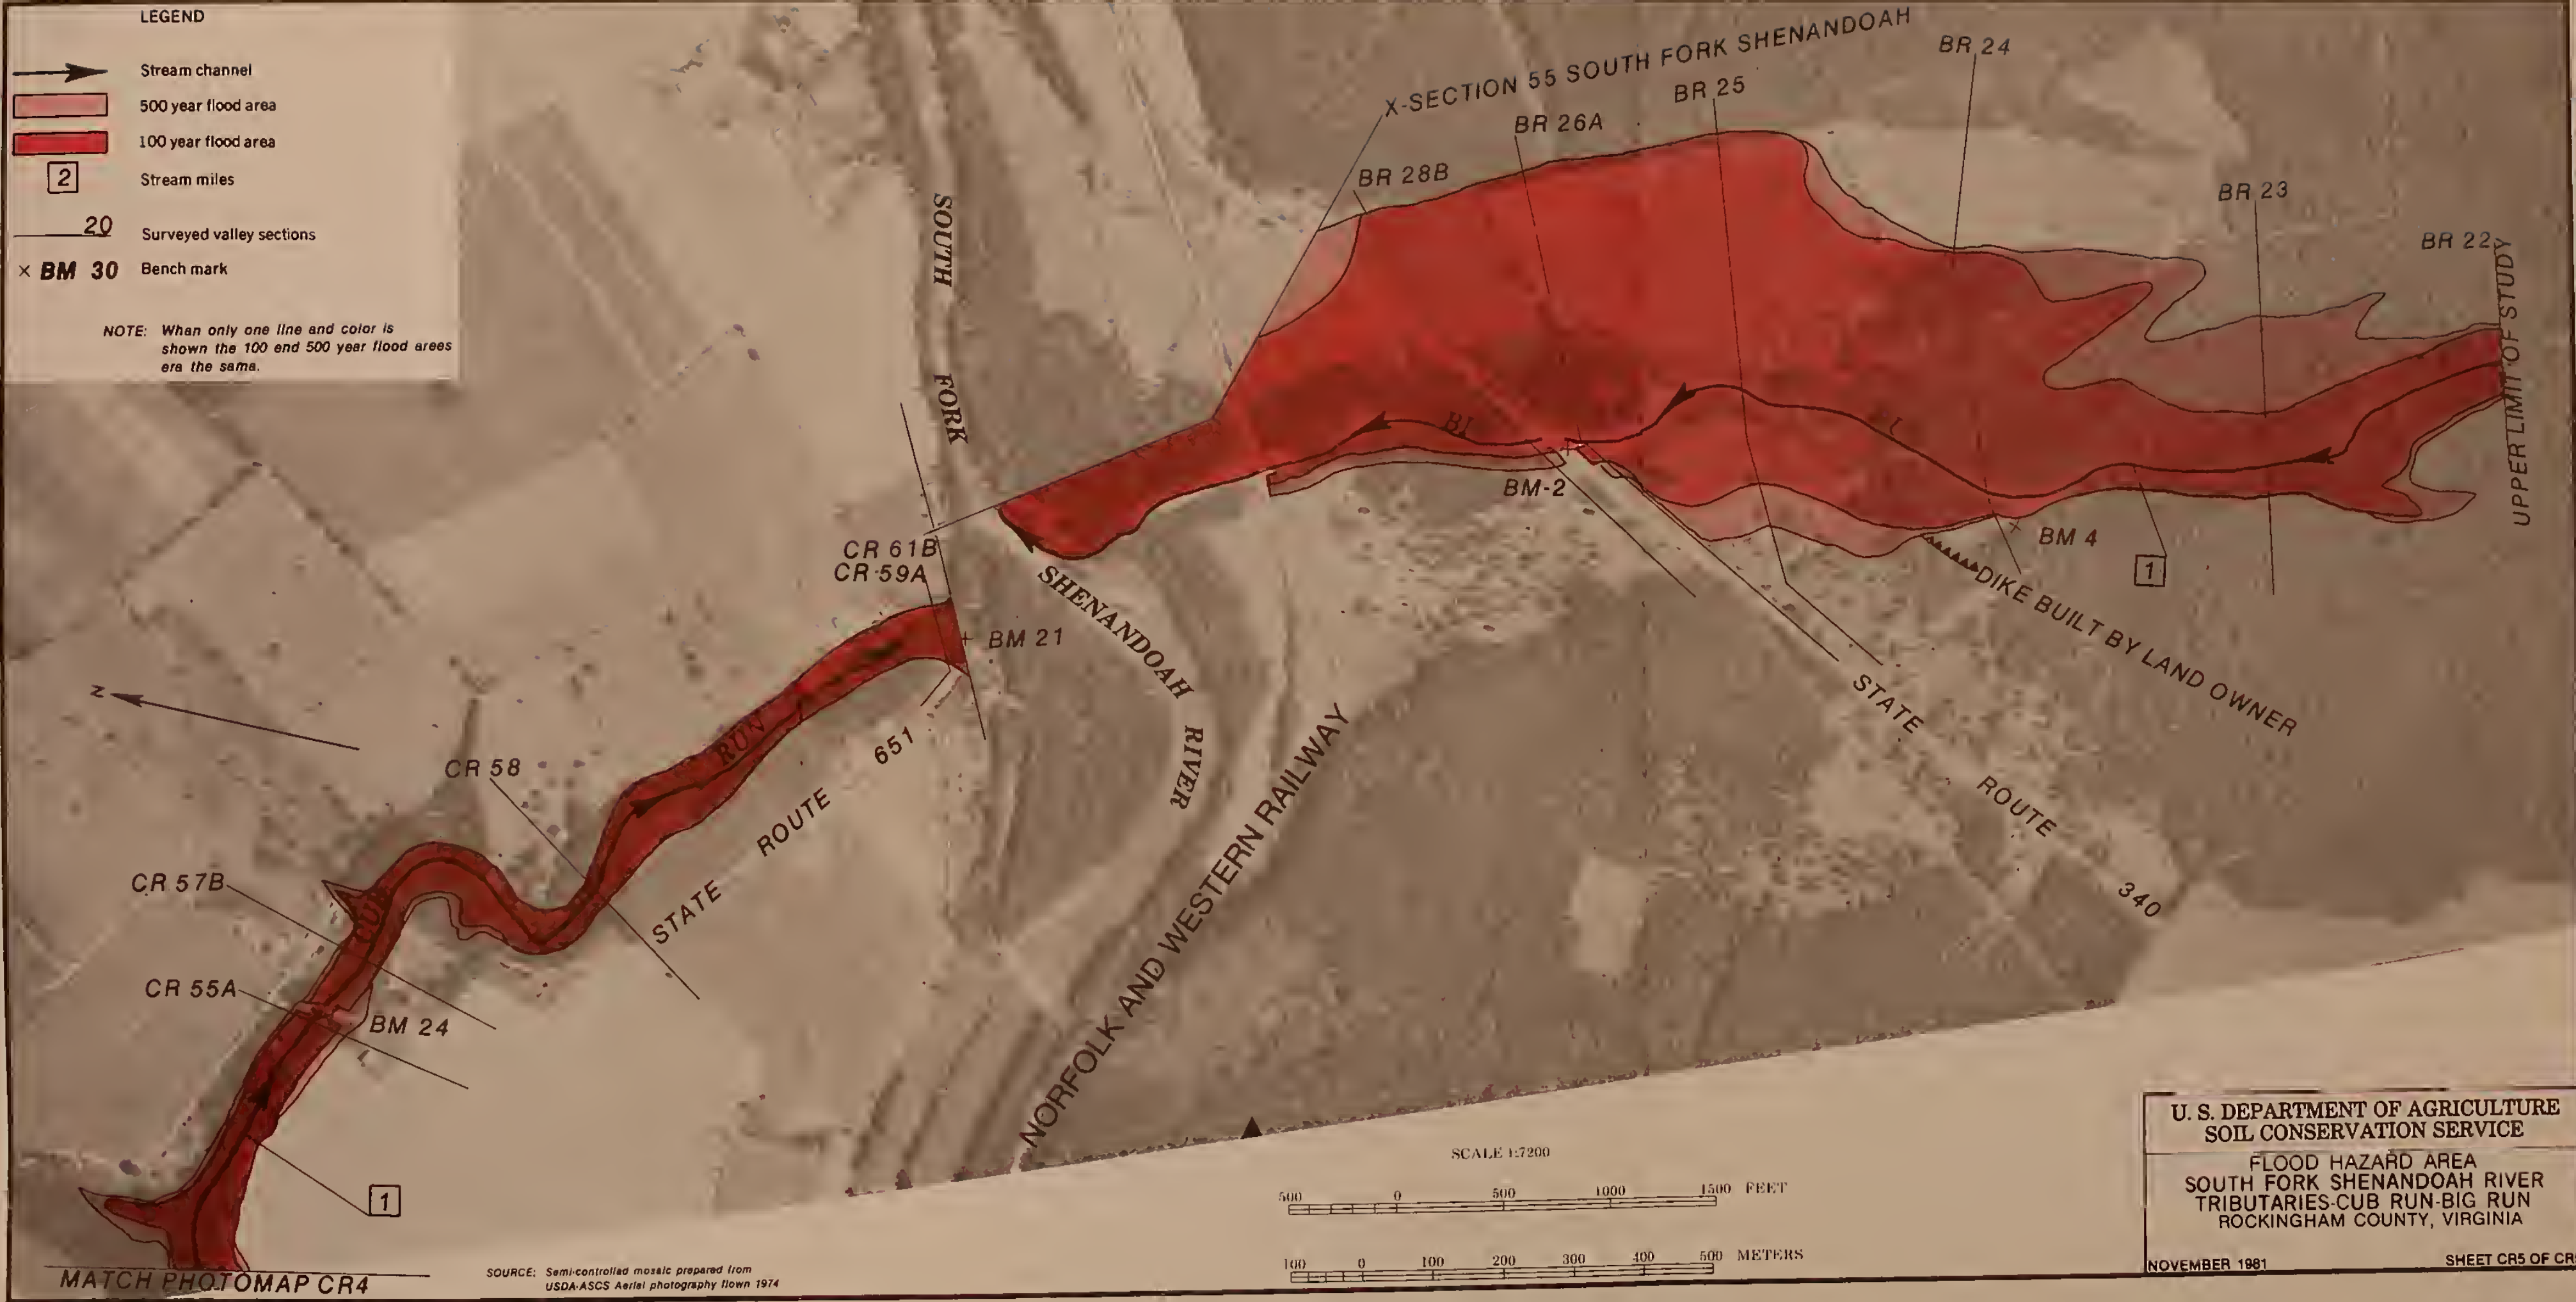
SOURCE: Semi-controlled mosaic prepared from  
USDA-ASCS Aerial photography flown 1974

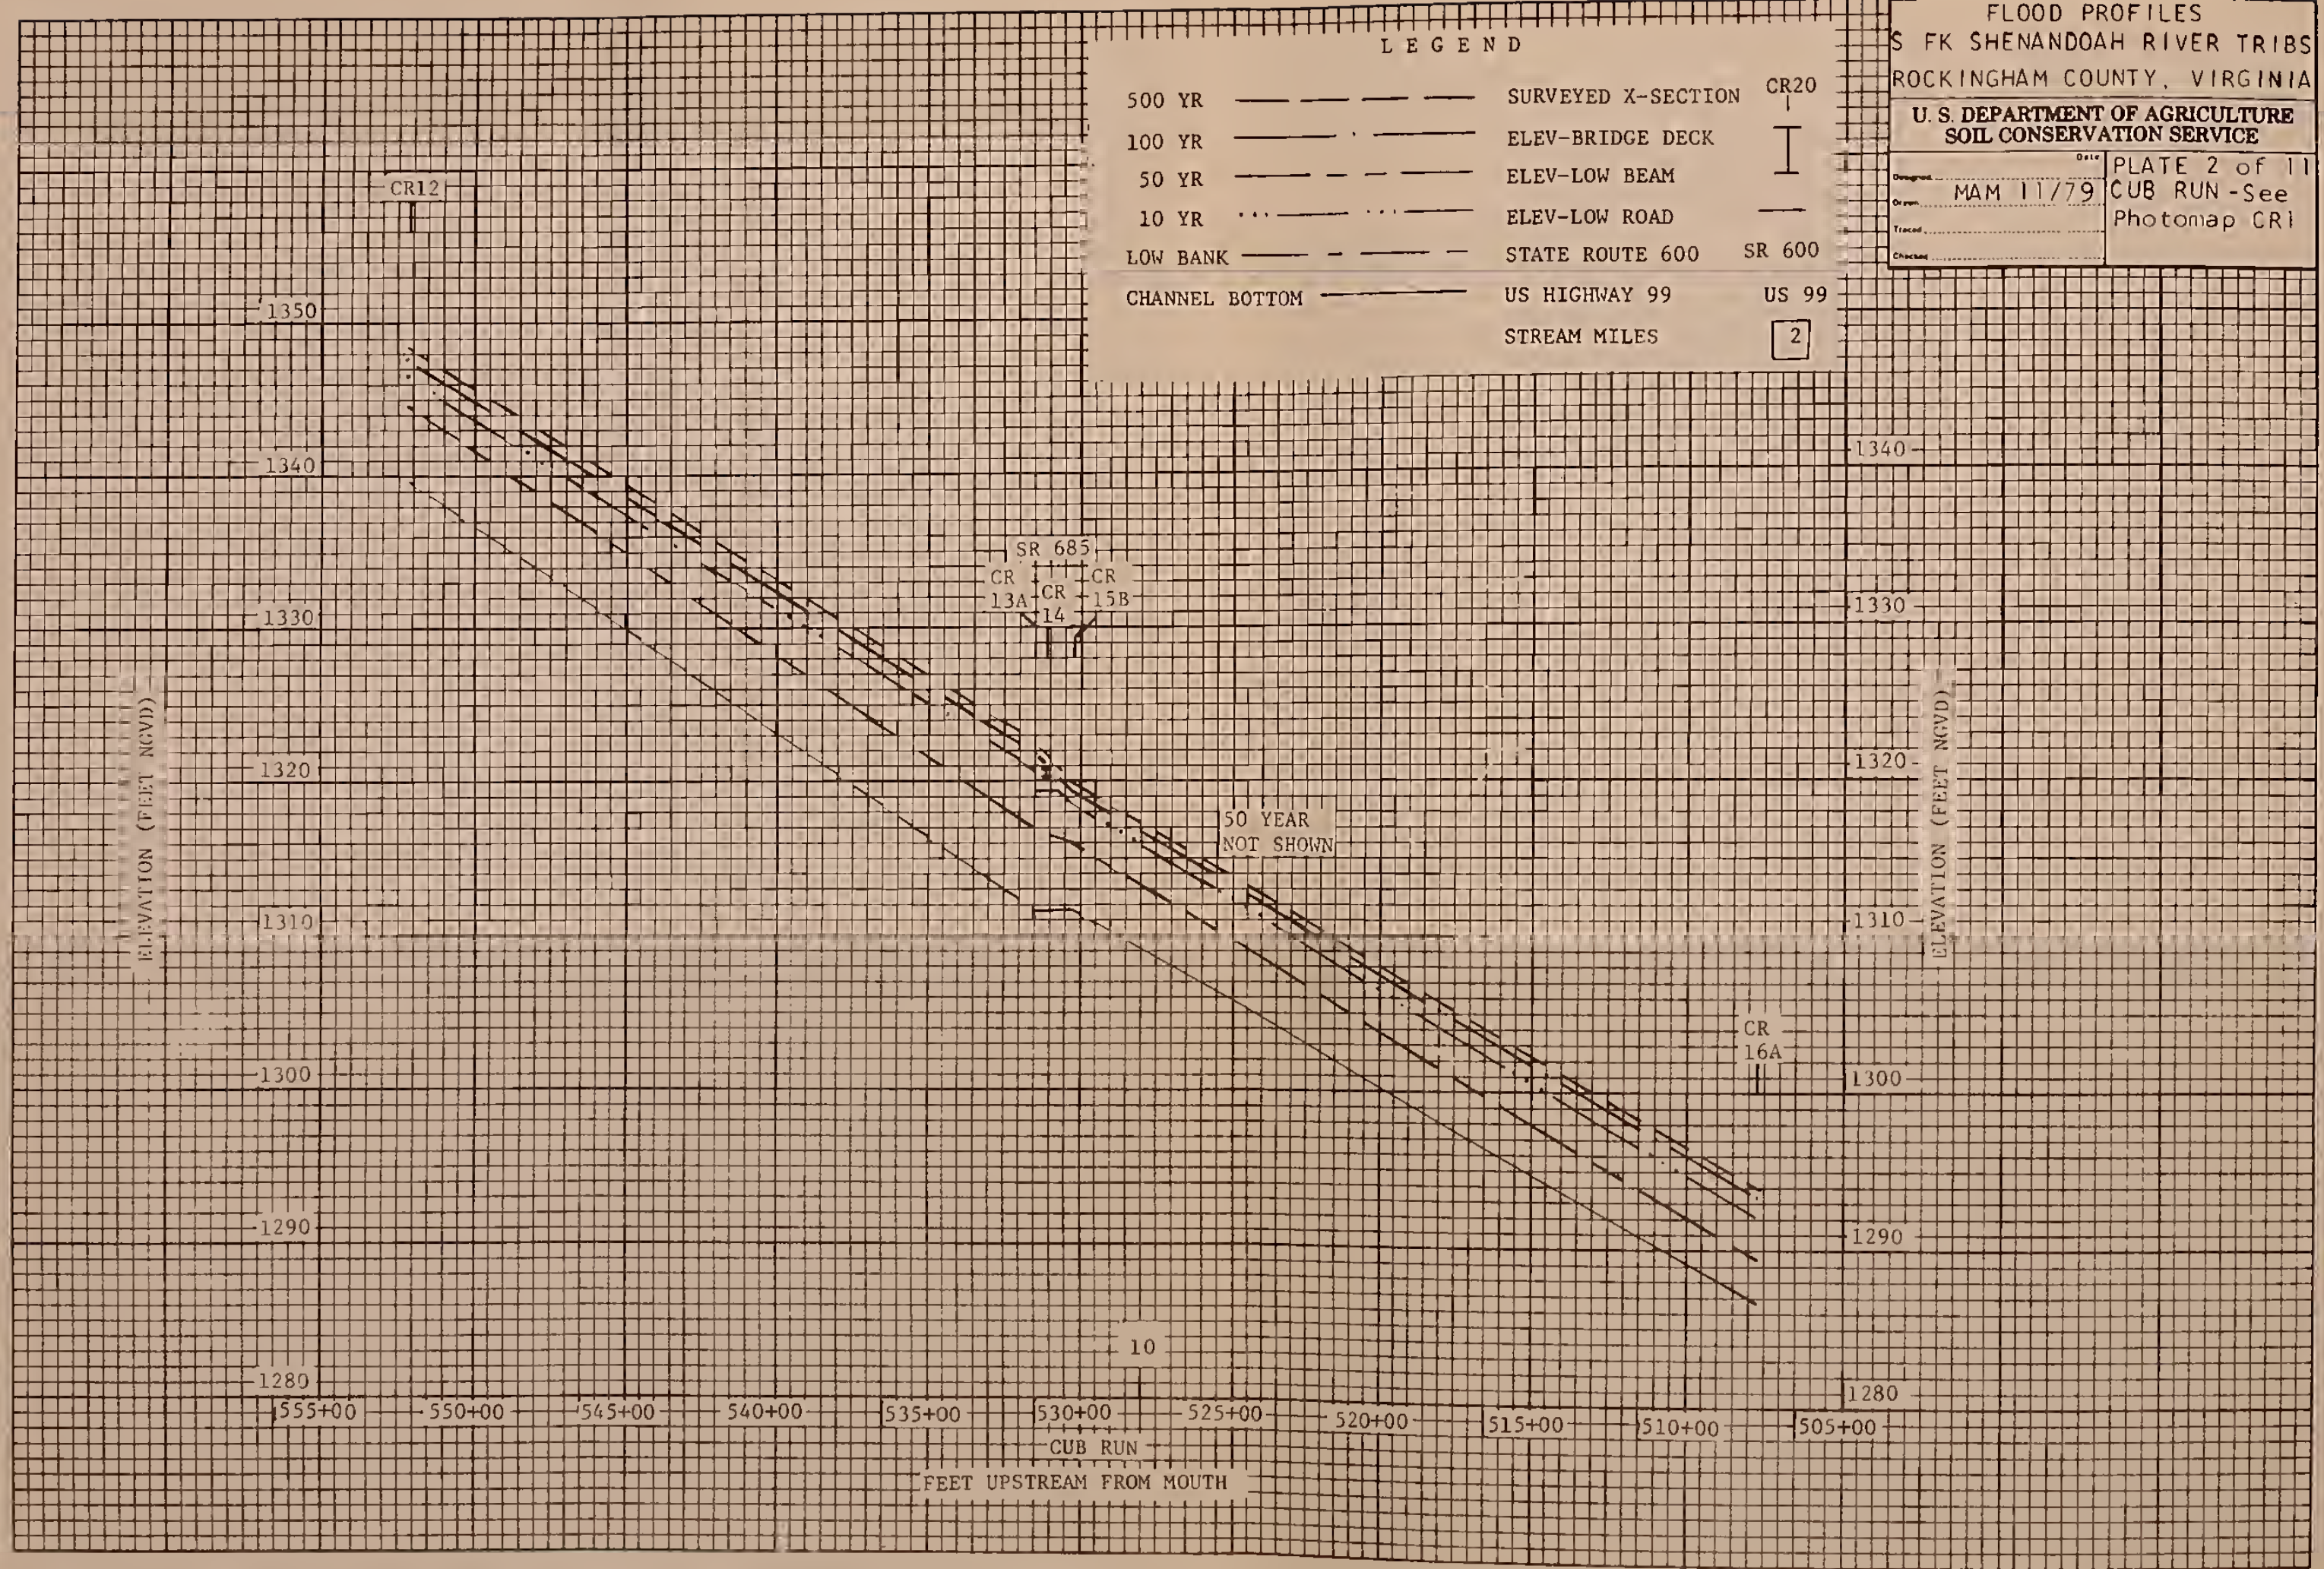
FLOOD PROFILES	
S FK SHENANDDAH RIVER TRIBS	
ROCKINGHAM COUNTY, VIRGINIA	
U. S. DEPARTMENT OF AGRICULTURE SOIL CONSERVATION SERVICE	
Designed: MAM 11779	DATE: PLATE 3 of 11
Drawn:	CUB RUN - See
Traced:	Photomaps
Checked:	CR1 & CR2

Flood profile plates provide elevations of the 10, 50, 100 and 500-year floods at any location along the length of the streams. The elevations and discharges of the 10, 25, 50, 100 and 500-year flood at each surveyed cross section are given in Table CR-1. Sample cross sections illustrated how the flood area boundaries were located. Table CR-2 provides the description and elevation of benchmarks which are located on the photomaps.
